Case Report

## A Broken Sewing Needle in the Knee of a 4-Year-Old Child: Is it Really Inside the Knee?

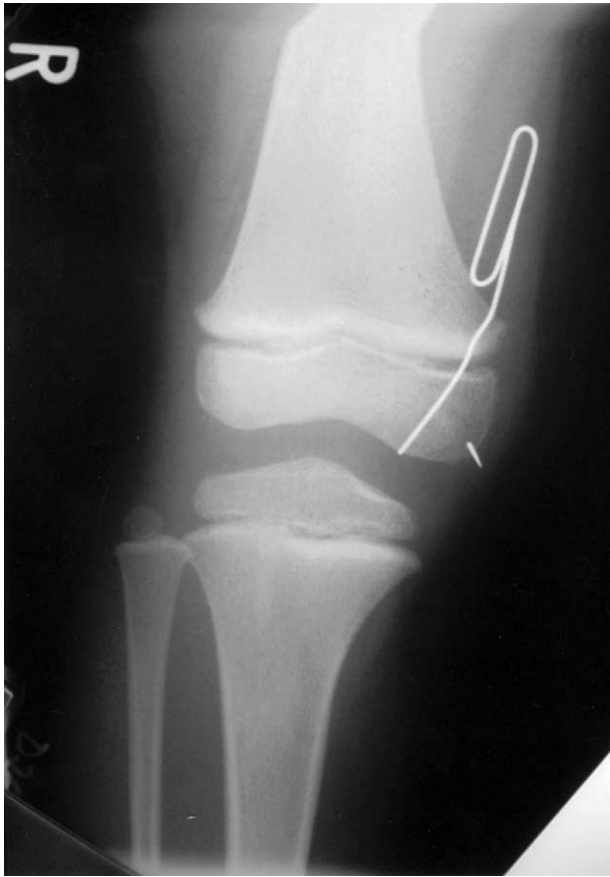
**FIGURE 1.** Initial anteroposterior radiograph corresponding to skin punctum mark, with external paper clip marker.

bed. However, she could walk normally. Her nanny found a broken piece of a sewing needle on the bed and noticed a puncture wound over the child's right knee. After admission, radiographs of the knee were taken. These confirmed the presence of a metallic foreign body (Figs 1 and 2).

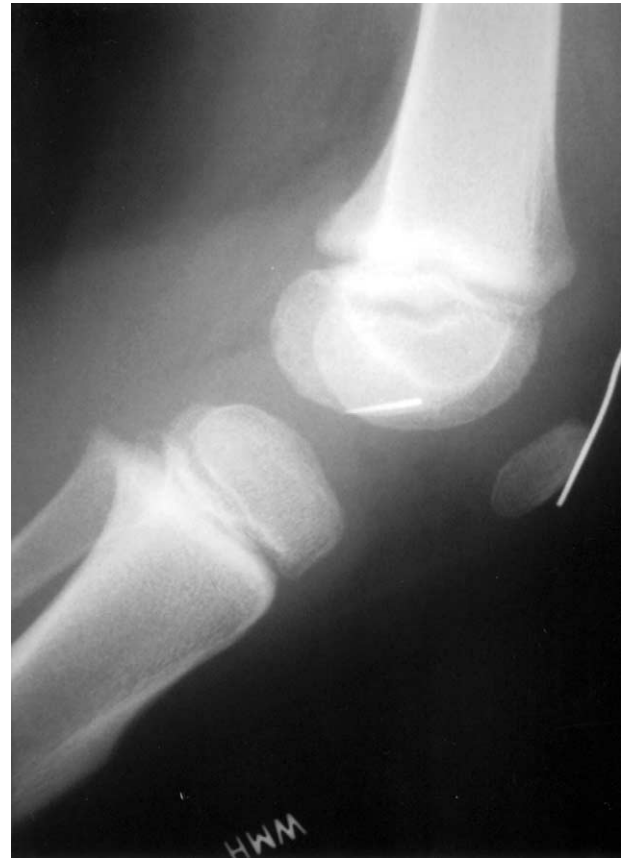
**FIGURE 2.** Initial lateral radiograph.

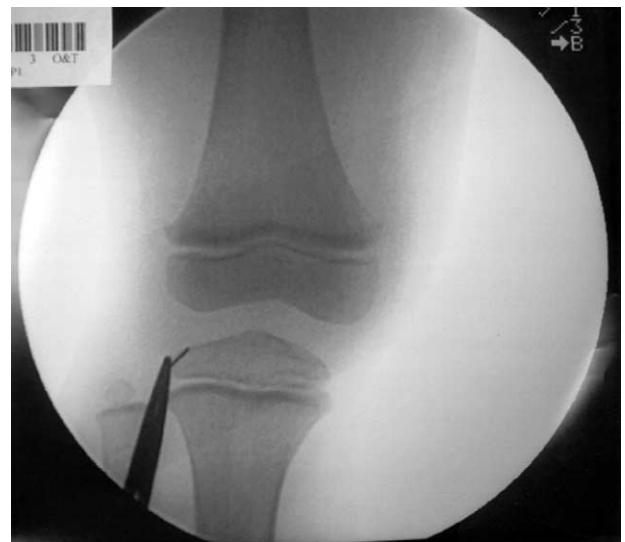
**FIGURE 3.** Intraoperative image intensifier showed relocation of needle to lateral side of knee. Skin incision needed to be reconsidered.

During surgery, an image intensifier showed that the needle tip had migrated to the posterolateral aspect of the knee (Figs 3 and 4). Arthroscopic examination was performed through the standard anterolateral portal using a 2.7-mm arthroscope. An anteromedial portal was also established for probing. Initially, no foreign body was seen in the corresponding area, and whether the needle was intra-articular or subcutaneous was uncertain. However, a capsular punctum was found on the medial side of the knee corresponding to

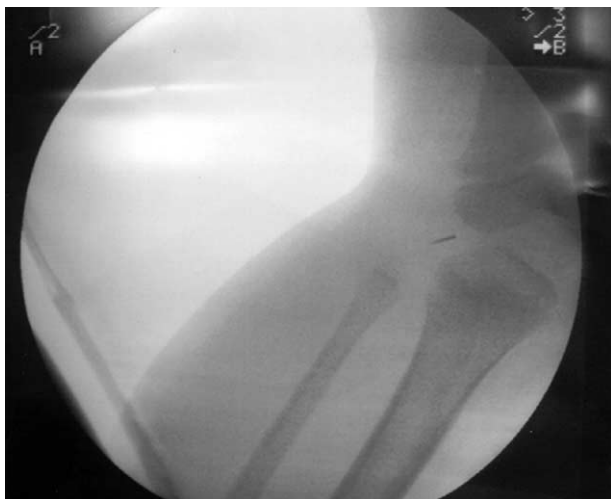
**FIGURE 4.** Intraoperative image intensifier confirmation of relocation of pin via intra-articular route.
